NATIONAL DAM SAFETY PROGRAM. DANSVILLE RESERVOIR DAM (INVENTORY--ETC(U)

DANSVILLE RESERVOIR DAM

STEBEN COUNTY, NEW YORK
INVENTORY NO. N.Y. 431

PHASE I INSPECTION REPORT
NATIONAL DAM SAFETY PROGRAM
DANSVILLE RESERVOIR DAM
N.Y. 431
DEC I.D. NO. 42-999
GENESEE RIVER BASIN
STEUBEN COUNTY, NEW YORK

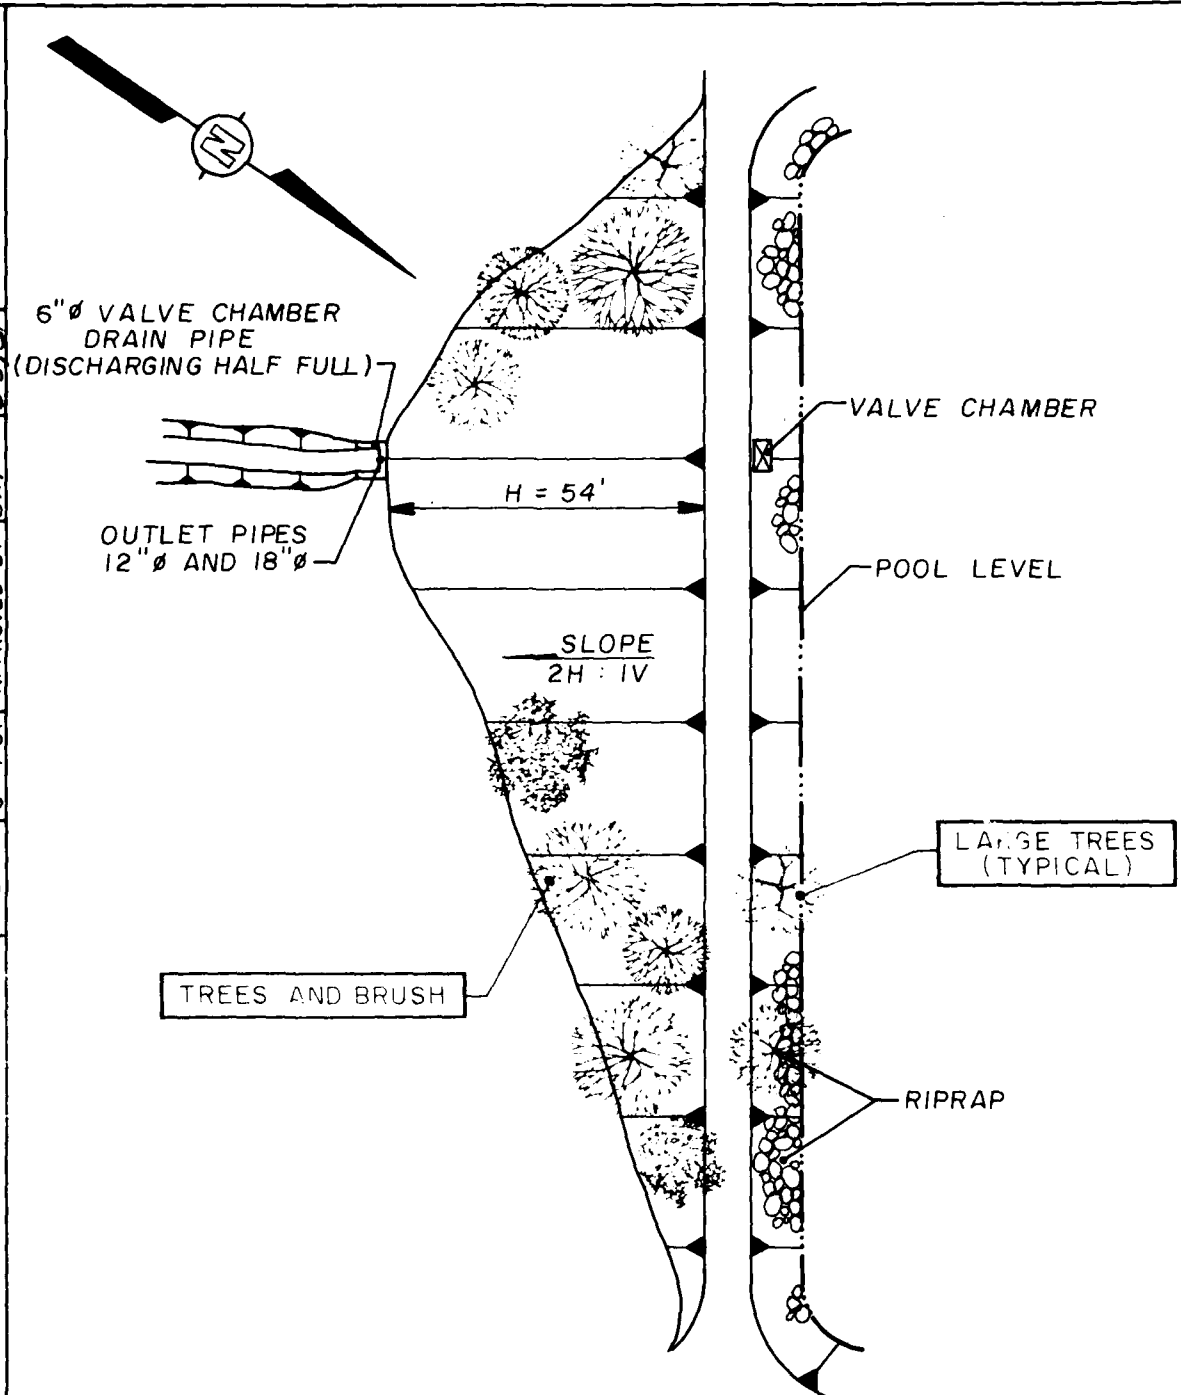
PLATE 4
 DANSVILLE RESERVOIR DAM
 GENERAL PLAN
 FIELD INSPECTION NOTES
 FIELD INSPECTION DATE : JUNE 26, 1981

NOTE :
 POOL LEVEL AT DATE OF INSPECTION : 1 FT. BELOW DAM CREST.
